Appendix E

Photograph Log

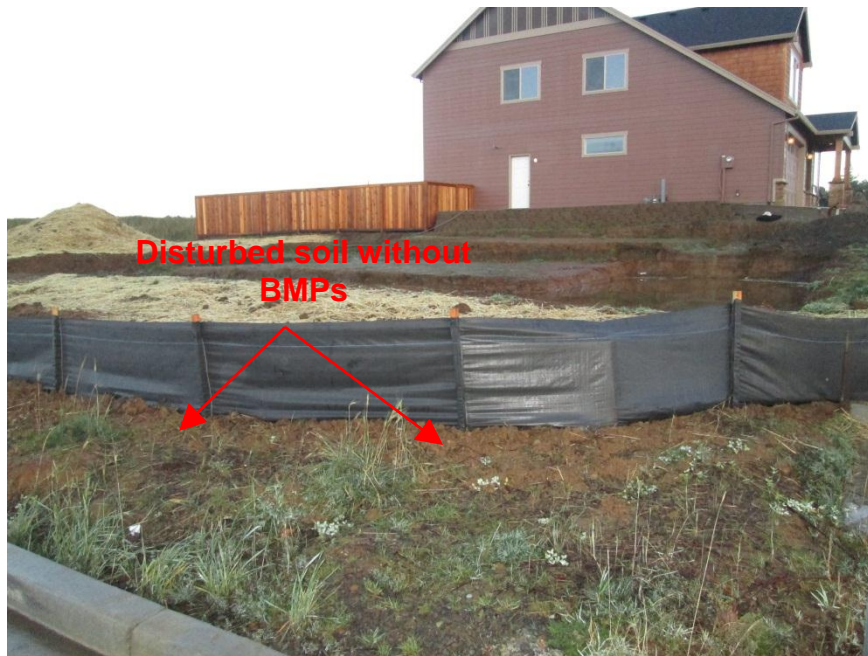
Photograph 1. Brookside Residential Development – View facing northwest of residential lot under construction. Note the disturbed soil beyond the silt fence without additional control BMPs on the southeast corner of the site.

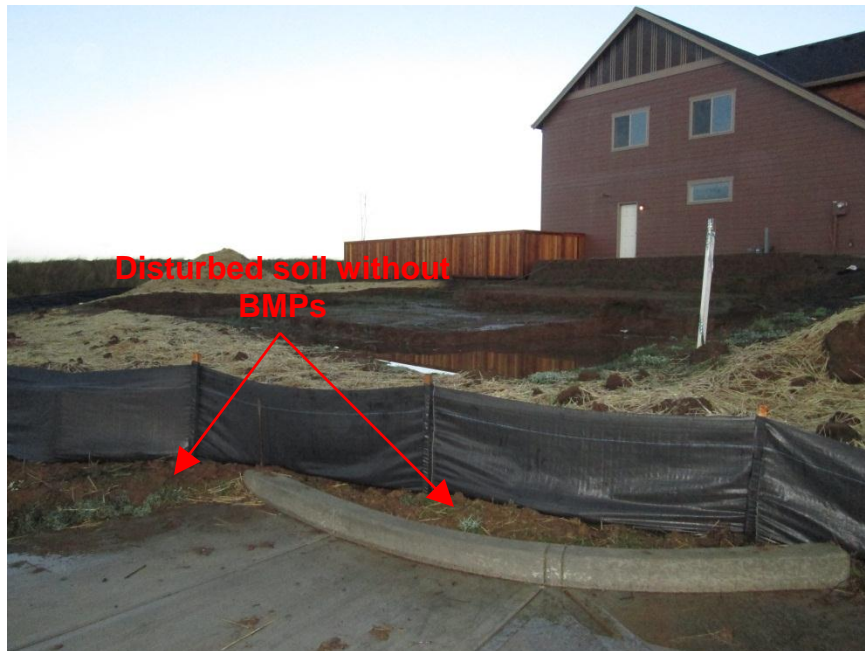
Photograph 2. Brookside Residential Development – View facing northwest of disturbed soil beyond the silt fence, without additional control BMPs.

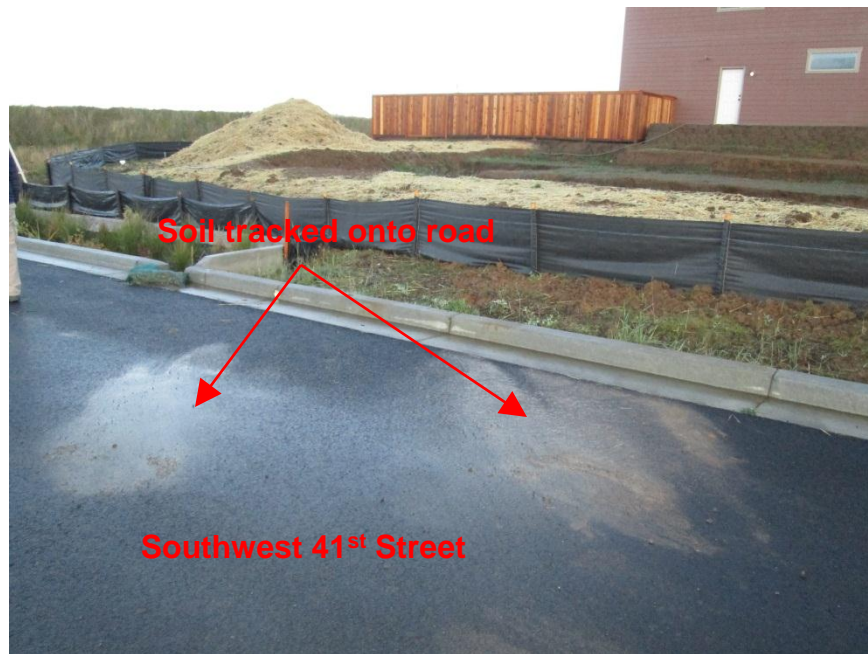
Photograph 3. Brookside Residential Development – View facing northwest of soil tracked onto the impervious surface adjacent to the site.

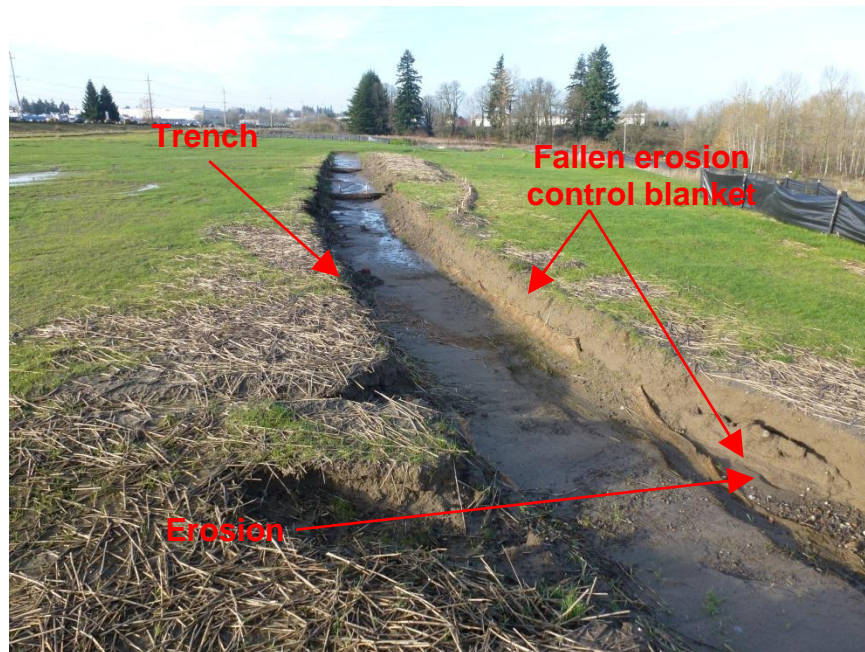
Photograph 4. Sandy Boulevard Open Fill Site – View facing west of erosion control blanket-lined trench in the central area of the site. Note erosion where the erosion control blanket is out of place.

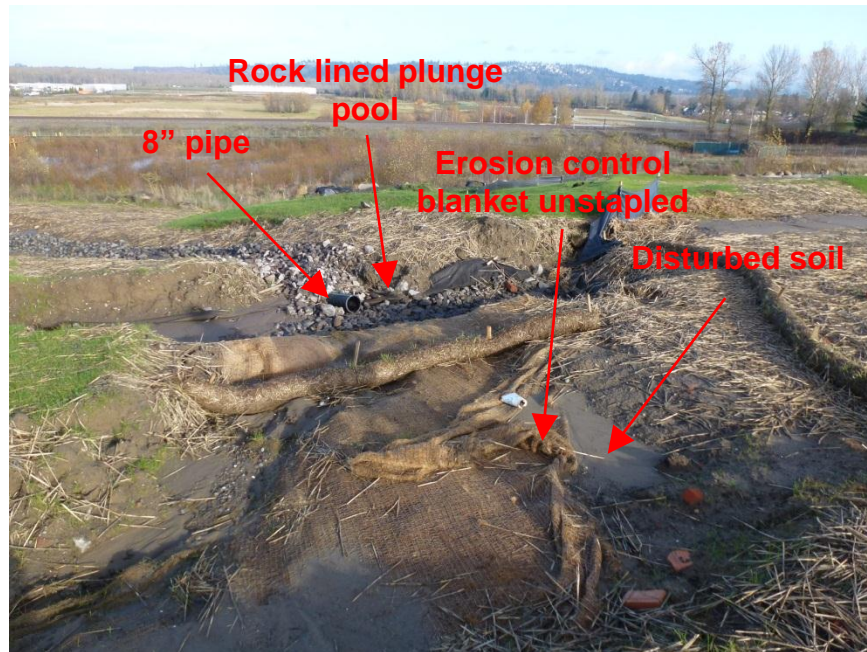
Photograph 5. Sandy Boulevard Open Fill Site – View facing north (east of trench shown in Photograph 4) of rock-lined plunge pool and out-of-place erosion control blanket. Note the disturbed soil where the erosion control blanket has become unstapled.

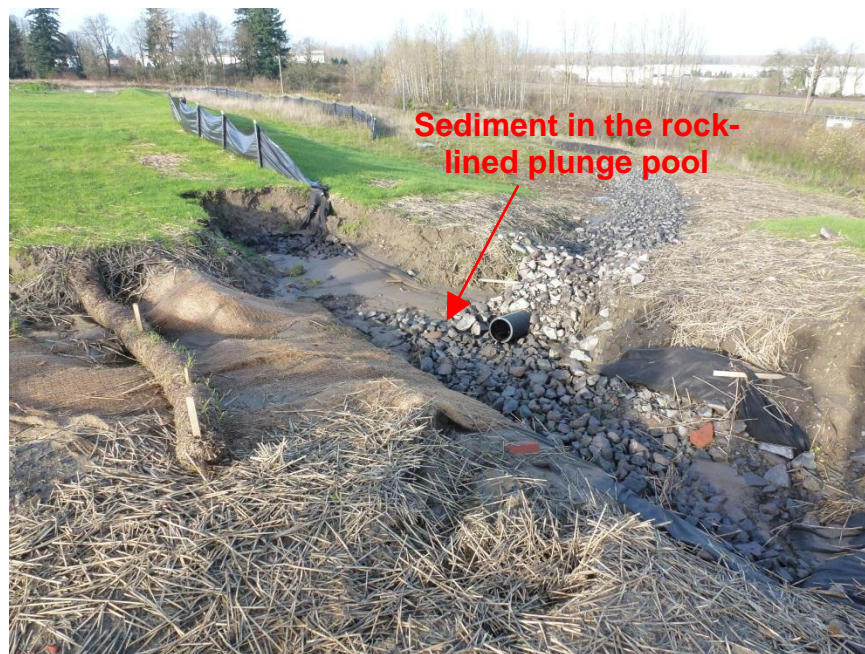
Photograph 6. Sandy Boulevard Open Fill Site – Closer view facing northwest of rock plunge pool, shown in Photograph 5, containing sediment on the northern side of the site. Note the sediment appeared to have been carried downgradient from the area with the fallen erosion control blanket.

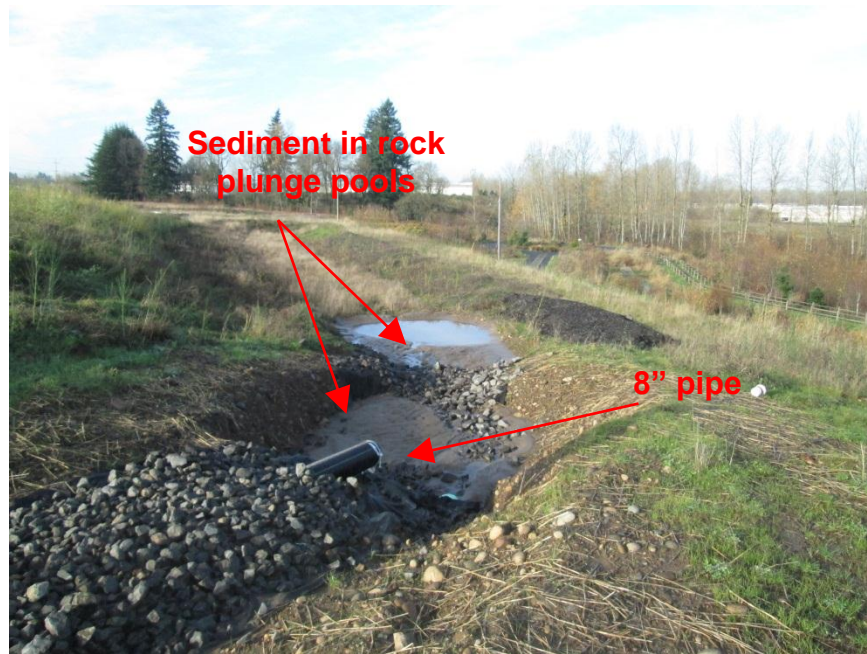
Photograph 7. Sandy Boulevard Open Fill Site – View facing west, on the northern side of the site, of rock plunge pools containing sediment. Note the downstream end of the eight inch pipe shown in Photographs 5 and 6.

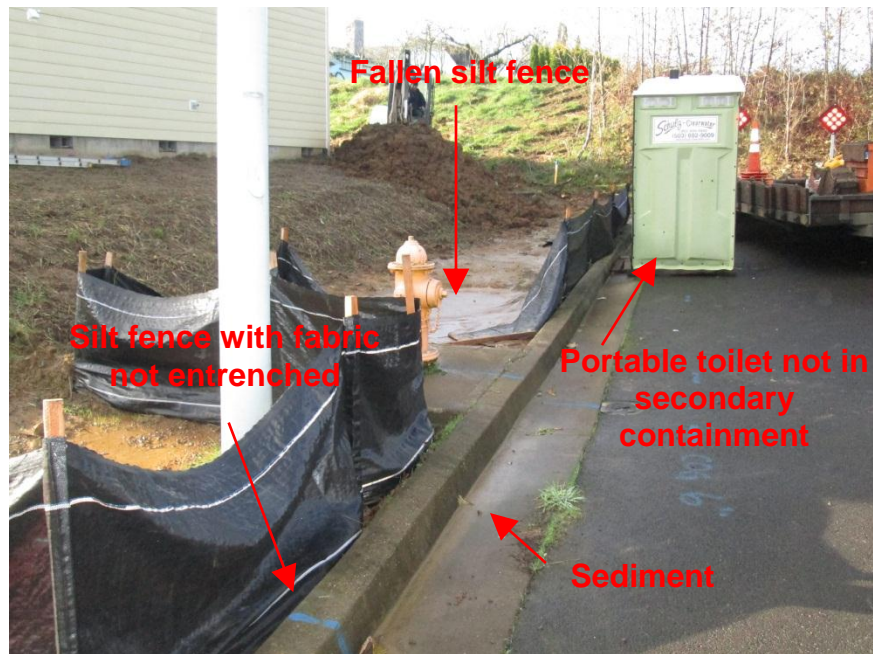
Photograph 9. Eastmont Estates Residential Development – View facing west of portable toilet not in secondary containment, fallen silt fence, and sediment on curbing on the north side of the northern lot.

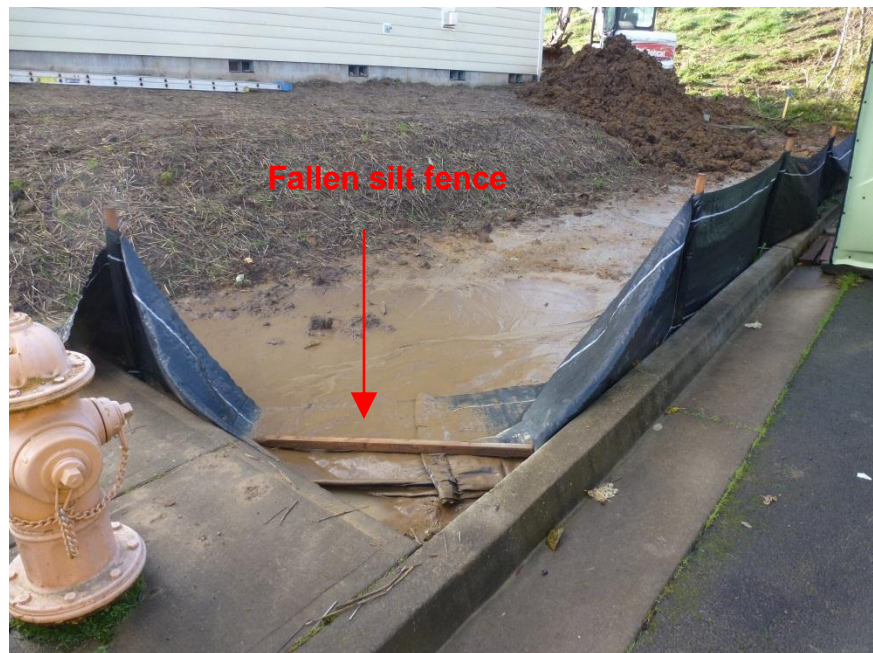
Photograph 10. Eastmont Estates Residential Development – Closer view of fallen silt fence shown in Photograph 5.

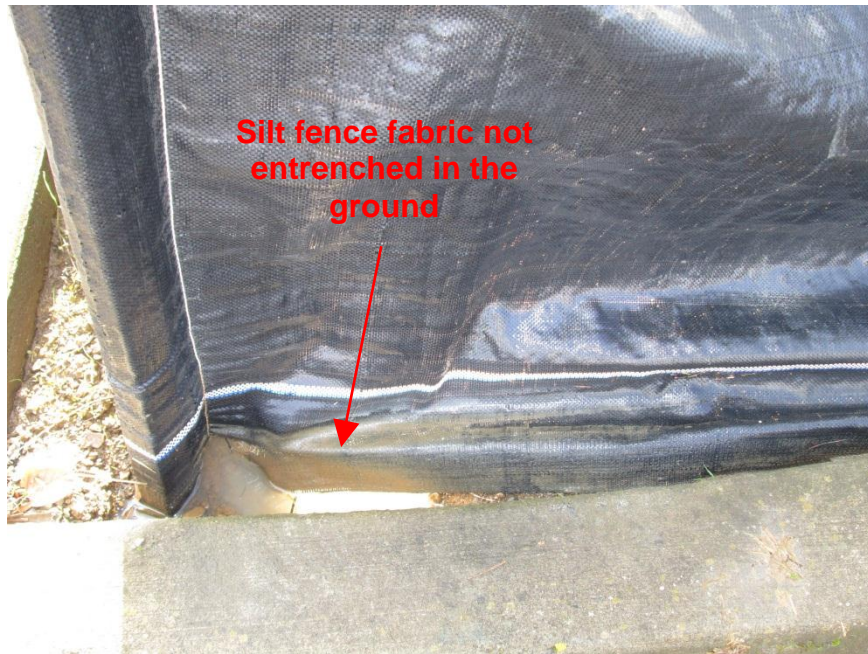
Photograph 11. Eastmont Estates Residential Development – Close-up view of silt fence not entrenched in the ground on the north perimeter of the northern lot.

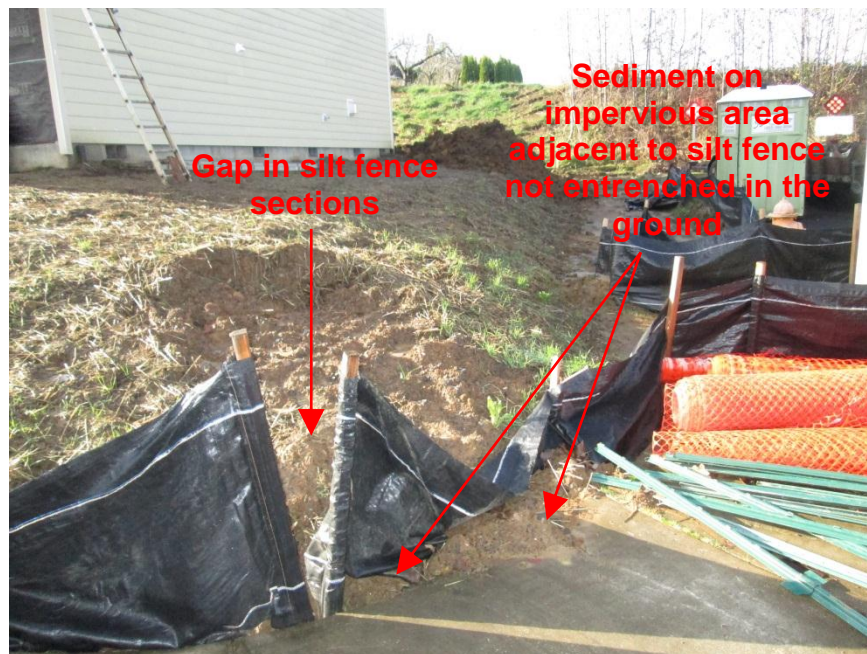
Photograph 12. Eastmont Estates Residential Development – View facing southwest of sediment on the impervious area directly adjacent to a silt fence that is not entrenched in the ground. Note that a gap exists between two silt fence sections.

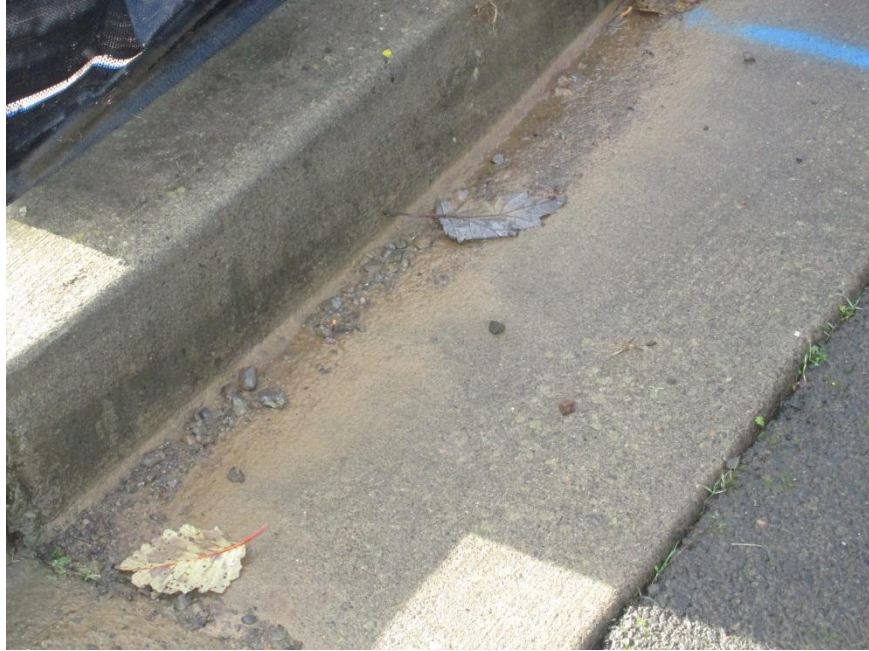
Photograph 13. Eastmont Estates Residential Development – Close-up view of sediment on curb shown in Photographs 9 and 10.

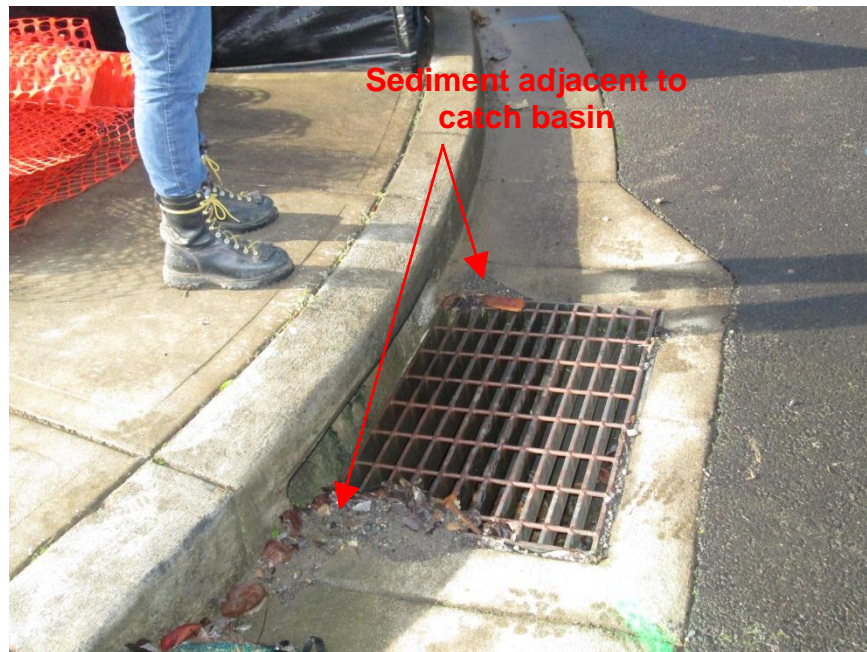
Photograph 14. Eastmont Estates Residential Development – View facing north of sediment directly adjacent to a catch basin located on the northeast corner of the northern lot.

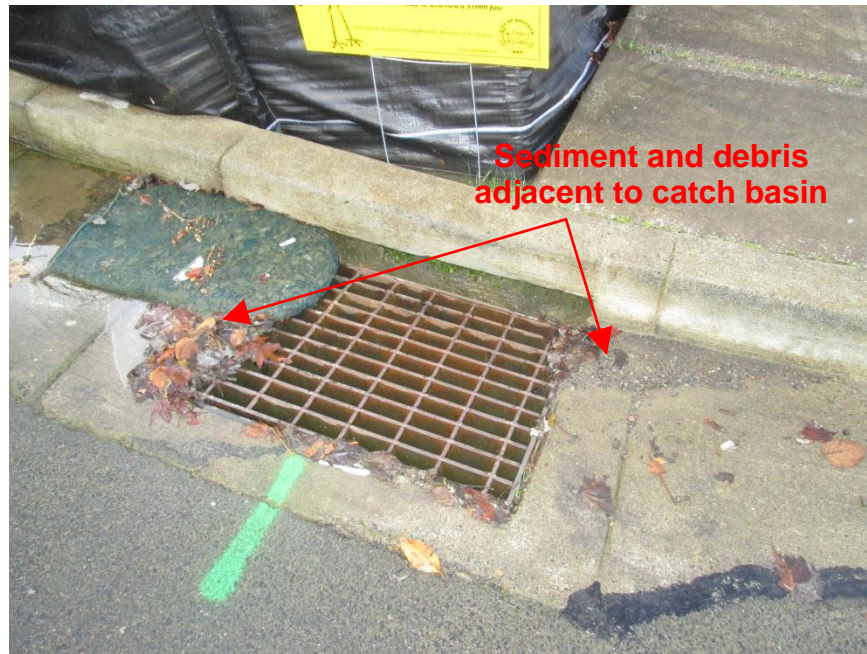
Photograph 15. Eastmont Estates Residential Development – View facing west of sediment directly adjacent to a catch basin located on the east side of the northern lot.

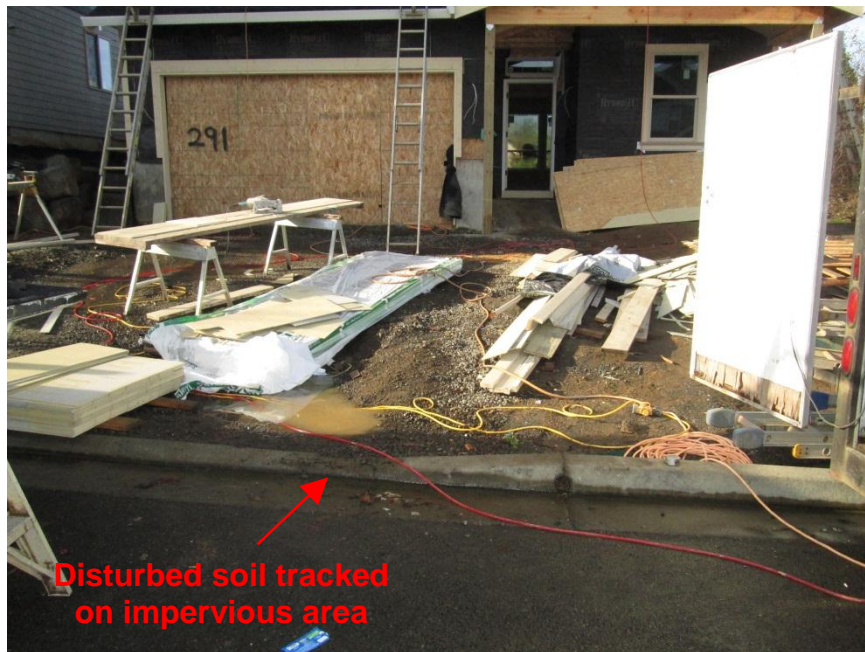
Photograph 16. Eastmont Estates Residential Development – View facing south of southern residential lot under construction in the development. Note that erosion and sediment control BMPs were not in place on the site and that the disturbed soil had been tracked on the impervious surface.

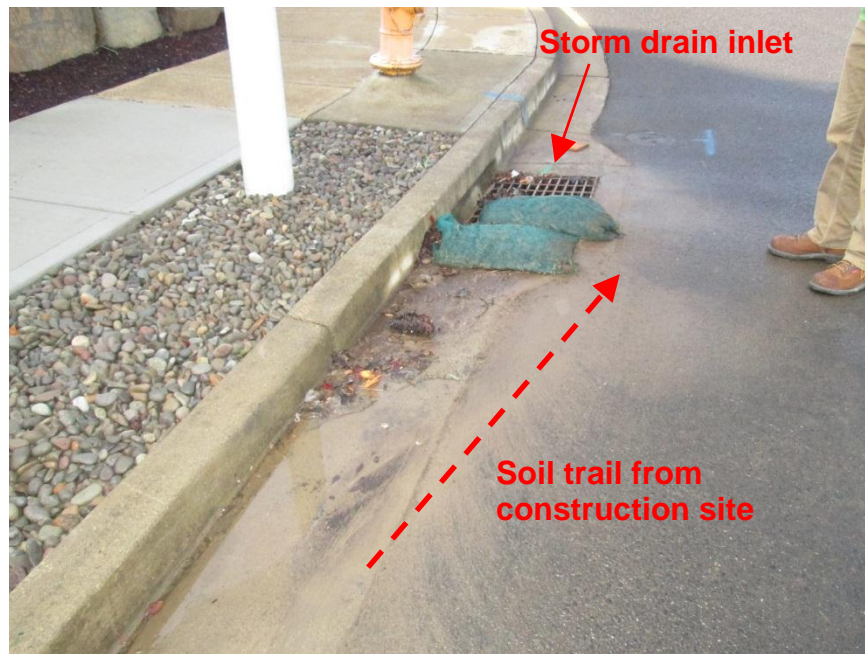
Photograph 17. Eastmont Estates Residential Development – View facing west of sediment trail from southern lot shown in Photograph 15 into stormdrain inlet west of the site.

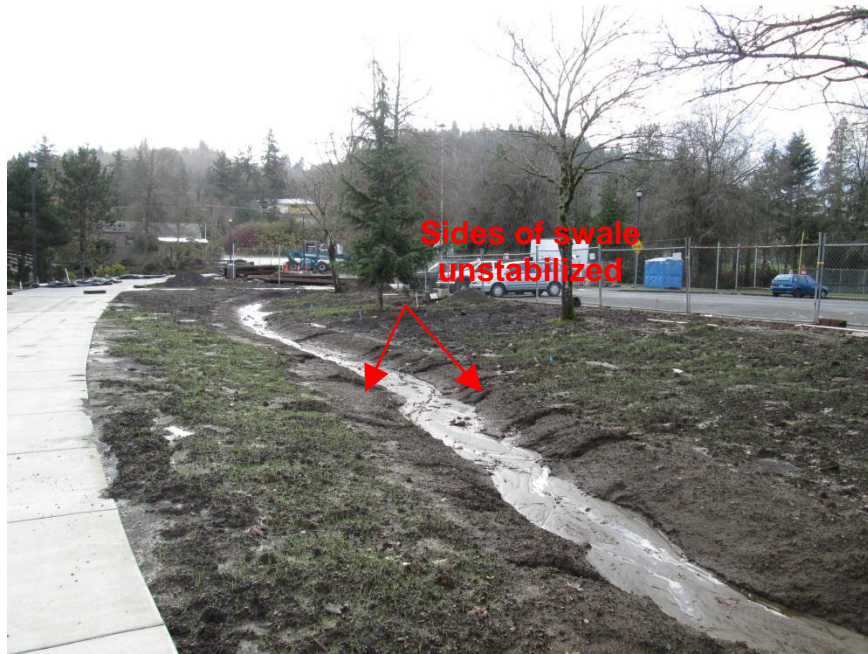
Photograph 19. Main City Park CIP Project – View facing south of a swale running adjacent to a parking lot toward the center of the park. Note the soil on the slopes of the swale is not stabilized.

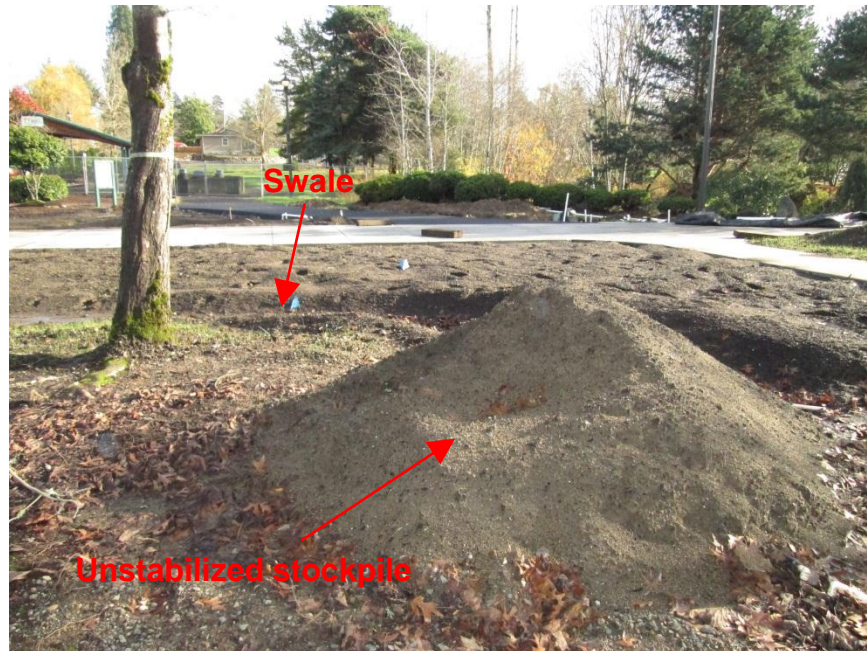
Photograph 20. Main City Park CIP Project – View facing southeast of unstabilized stockpile.

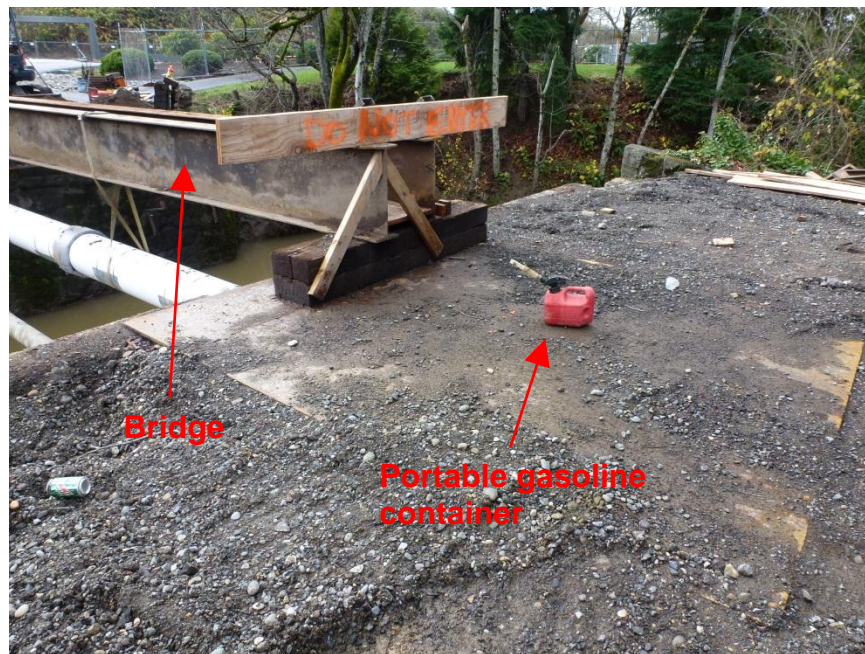
Photograph 21. Main City Park CIP Project – View facing southwest of bridge construction. Note the portable gasoline container near the bridge abutment edge.
